Evaluation of current status of seagrasses and marine ecosystem health in St. Jean Bay, St. Barthelemy FWI

A Sustainable Ecosystems Institute, St Jean Bay Science Group Report

August 2009

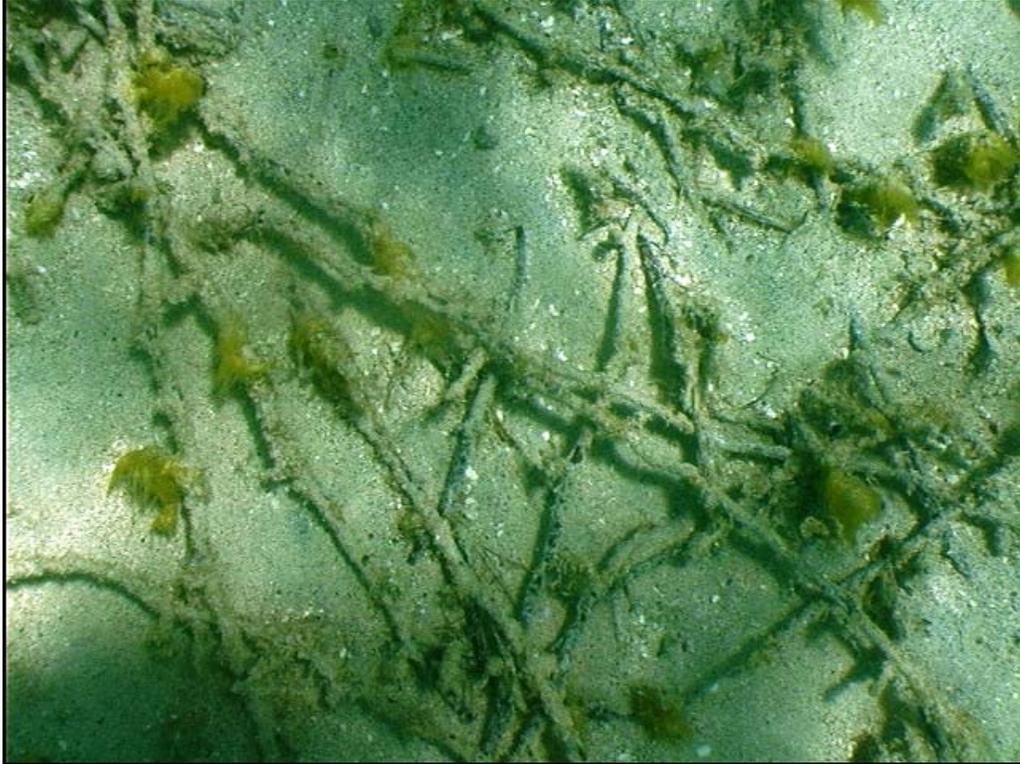
A small, dense mixed bed of turtle grass (*Thalassia testudinum*) and manatee grass with lesser amounts of shoal grass exists at the north end of the bay adjacent to the shoreline. The interior of this mixed bed appeared visually healthy with low epiphytic cover (Photos 4 and 6). However, the bed edges were extremely eroded, and a strong current was encountered in April 2009. The current had exposed the turtle grass rhizome mat, and the majority of the exposed rhizomes were dead (Photos 1 and 2). In mature turtle grass beds, rhizomes typically form a tightly woven mat approaching a half meter thick, and the rhizomes are generally buried approximately 8 to 25 cm below the sediment surface. Because *Thalassia* rhizomes are extremely strong binders of sediment, exposure of the rhizome mat has reduced the sediment trapping capability of the seagrass bed and has destabilized the remainder of the bed. Erosion of the bed edge was attributed to the high current velocity. No physical measurements of current velocity were performed during the site visit.

Photo 1: Exposed rhizomes of turtle grass (*Thalassia testudinum*) along beds edges in the western section of St. Jean Bay, April 2009

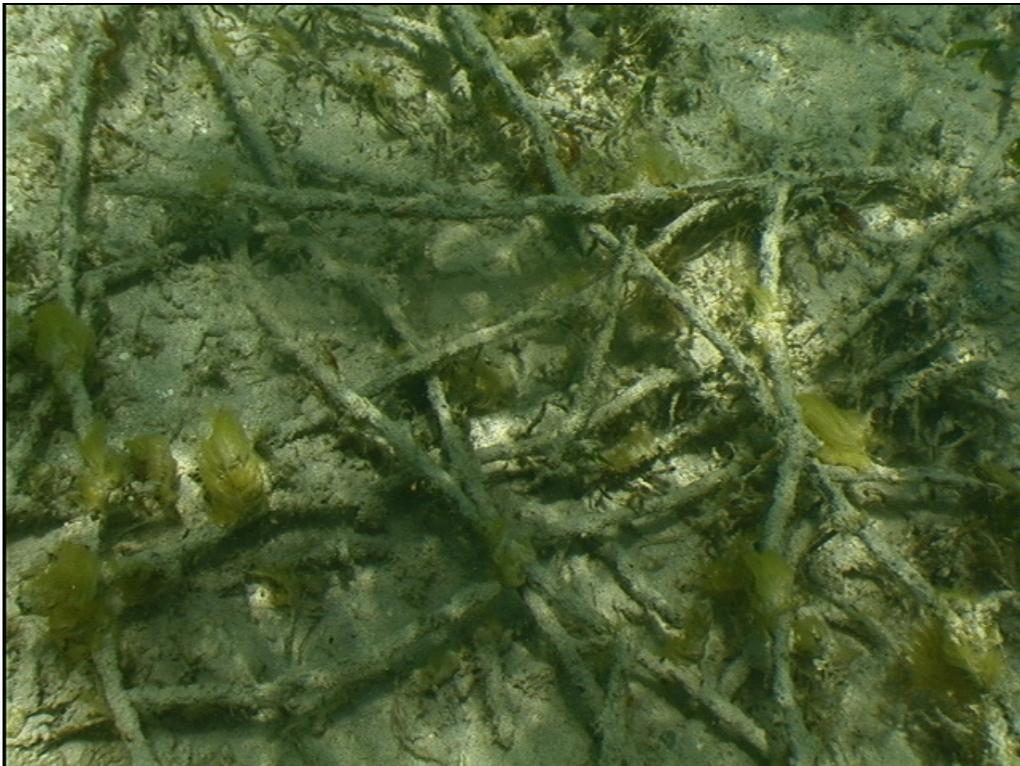
Photo 2: Exposed rhizome mat of turtle grass in western section of St. Jean Bay, April 2009

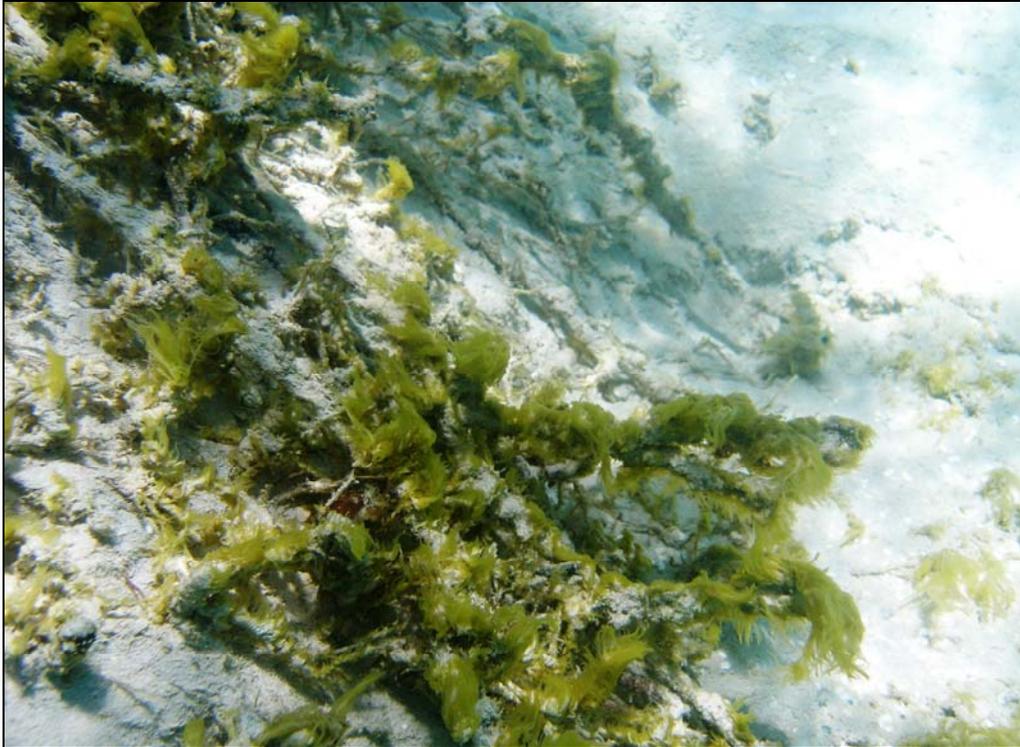
reefs were covered in dense overgrowth of filamentous cyanobacteria such as *Lyngbya* spp. (Photos 5 and 6), and the exposed *Thalassia* rhizome mats were also overgrown with *Lyngbya* and other filamentous cyanobacteria (Photos 1-3). Heavy cyanobacterial overgrowth was observed on the branching stony corals such as *Porites porites* on the western reef (Photo 5). The proliferation of this epiphytic cyanobacteria suggests significant nutrient pollution into St. Jean Bay. Proliferation of filamentous cyanobacterial mats is a typical indicator of high sewage inputs and/or elevated phosphorus to nitrogen ratios.

Photo 3: Overgrowth of filamentous cyanobacteria *Lyngbya* sp. on exposed rhizome mat of turtle grass, April 2009

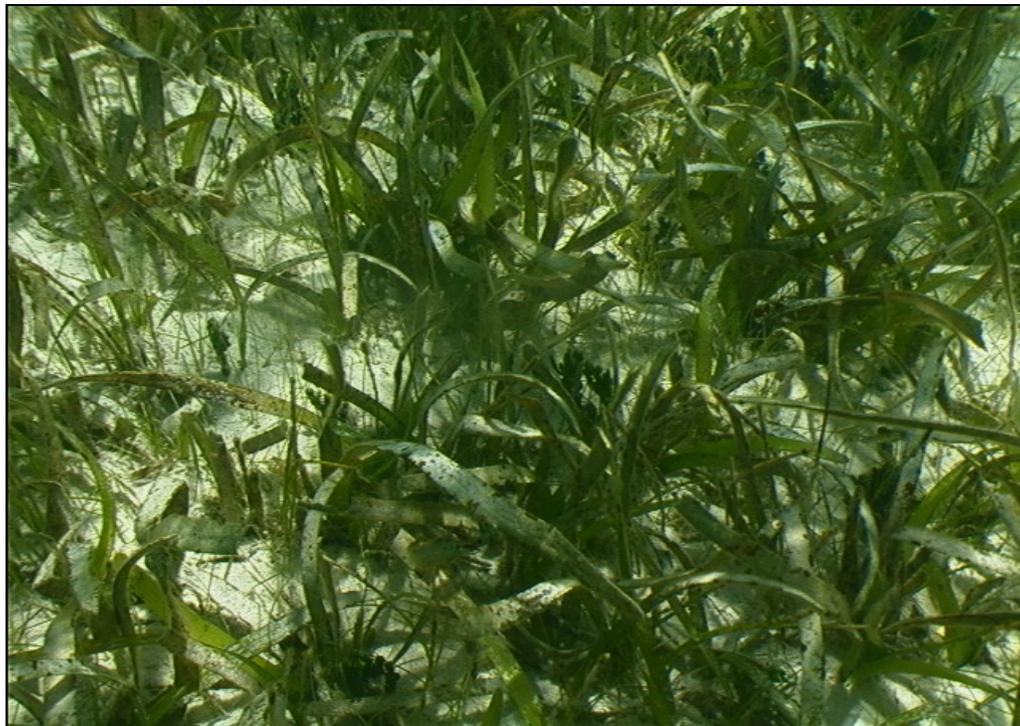
Photo 4: Healthy, dense mixed bed of turtle grass and manatee grass with low epiphytic cover, west St. Jean Bay along north shoreline, April 2009

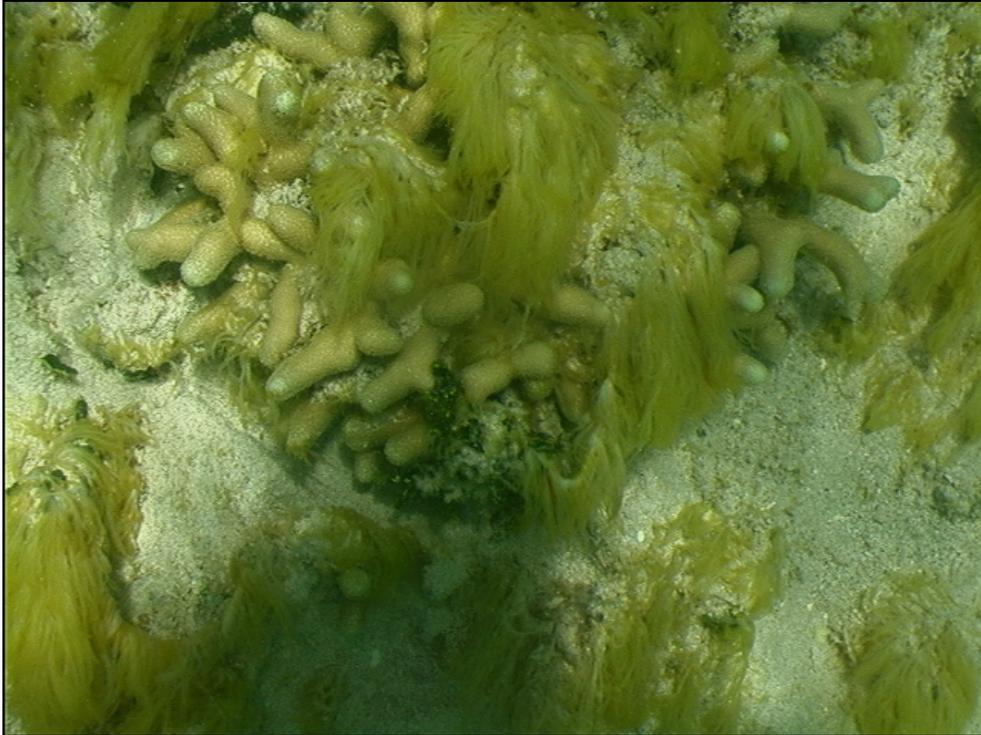
Photo 5: Heavy overgrowth of cyanobacteria on *Porites* on western section of reef in St. Jean Bay, April 2009

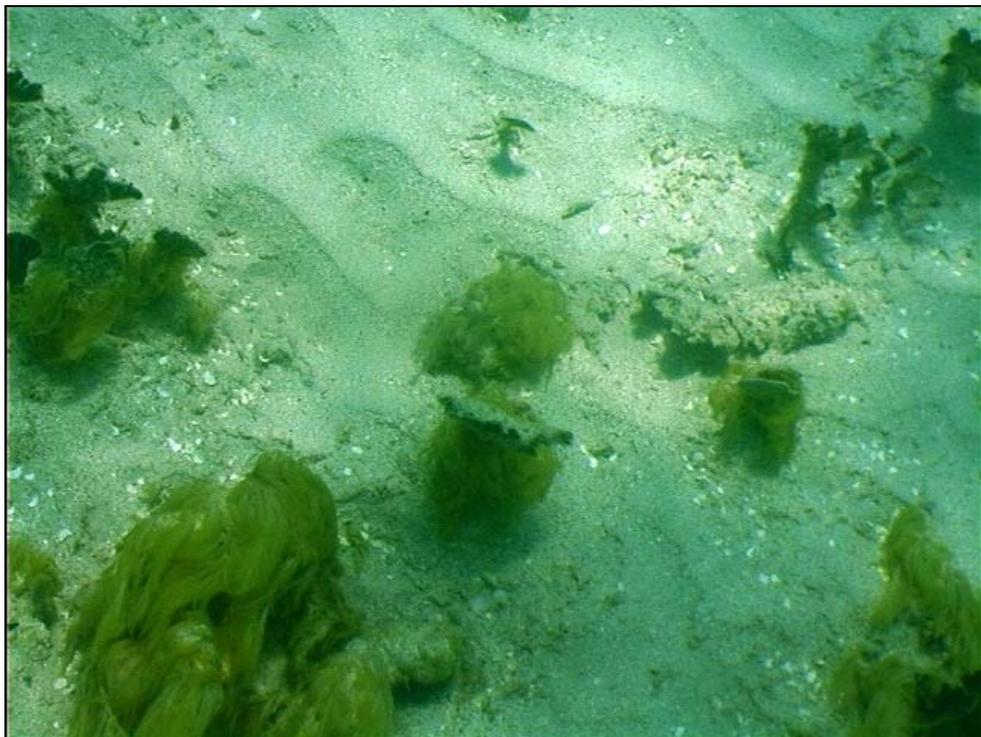
Photo 6: Overgrowth of *Lyngbya* on calcareous macroalgal beds in western section of St. Jean Bay, April 2009

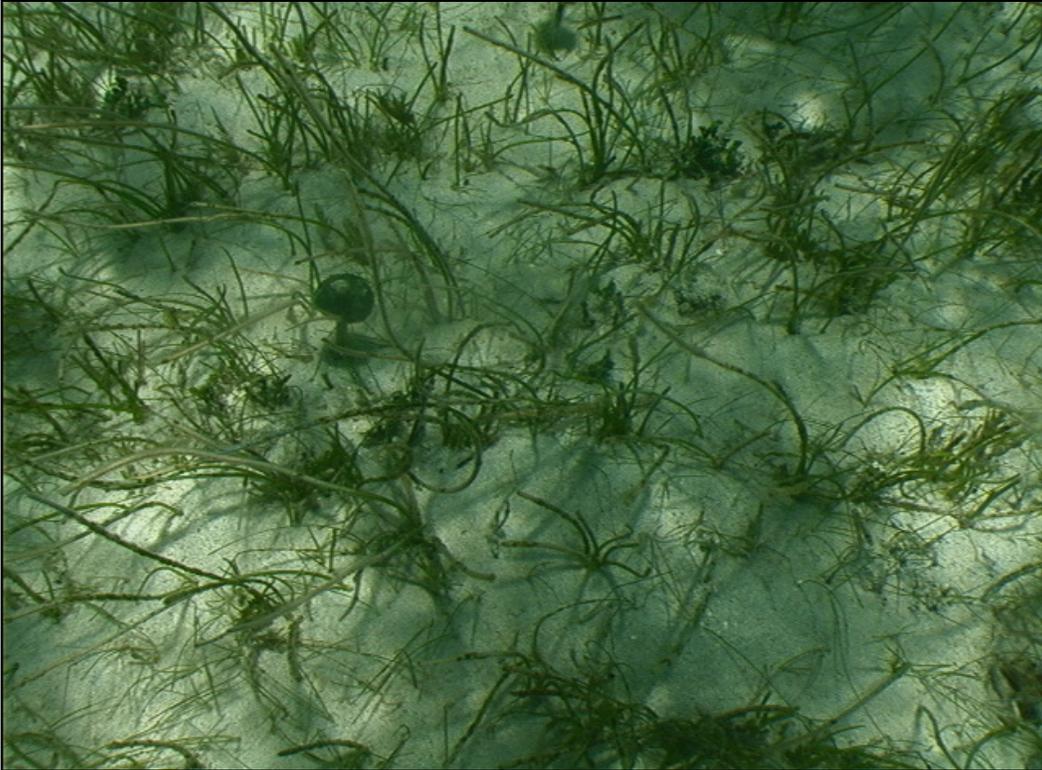
Photo 7: Manatee grass and shoal grass with calcareous green macroalgae in western section of St. Jean Bay, April 2009

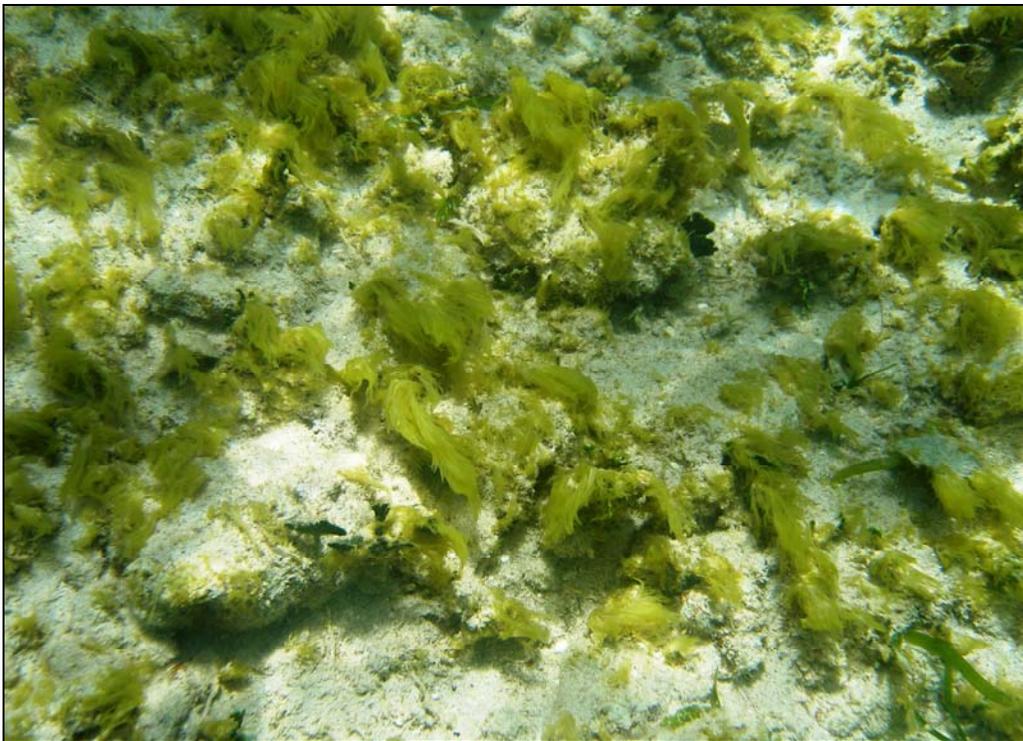
Photo 8: Heavy overgrowth of *Lyngbya* on western reef in St. Jean Bay reef, June 2009

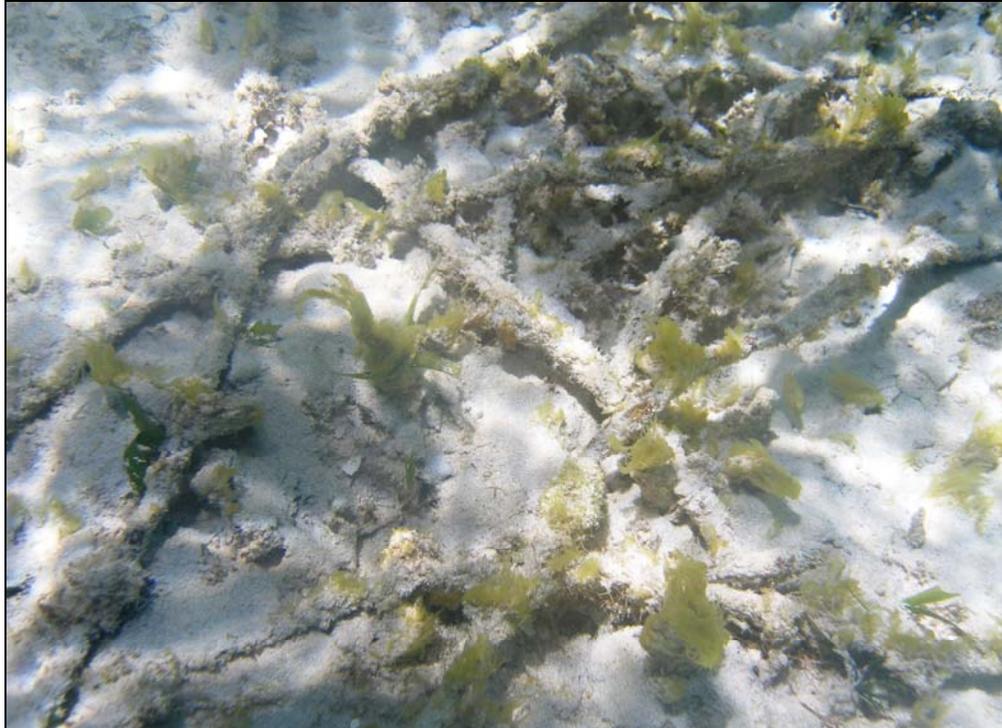
grass rhizome mat since April, and new growth of shoal grass and turtle grass was observed in these areas (Photos 9 and 10). A recent bathymetry survey provided by Mr. Xavier David suggested that the dredged channel and holes created during the 2007 beach fill project had been filled with sand, possibly reducing the erosion rate on the western side of the bay. Additionally, redistribution of sand from the beach fill project may be serving as a source of fine sediments to this area. Although the rhizome mat is dead on the sediment surface, it is functioning at a reduced level to slowly trap fine sediments. However, any strong storm or wave action could disrupt this process and destroy the network of dead surface rhizomes.

Photo 9: Exposed rhizome mat of turtle grass in western section of St Jean Bay showing signs of sediment accumulation and *Lyngbya*, June 2009

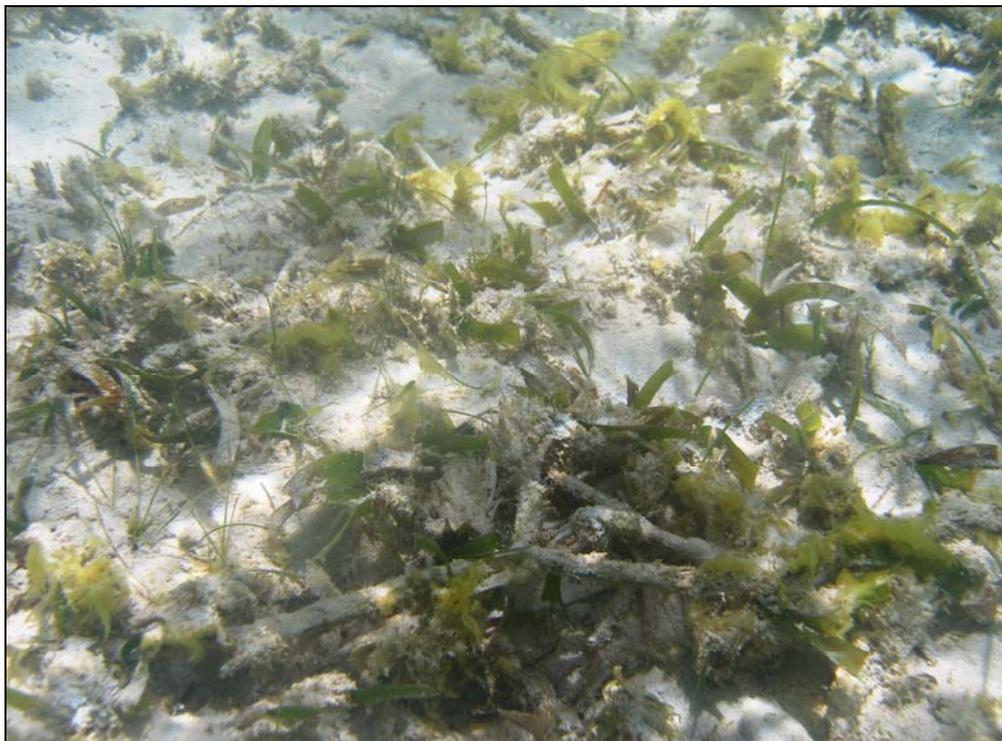
Photo 10: New growth of turtle grass and shoal grass in area of exposed rhizome mat in western section of St Jean Bay, June 2009

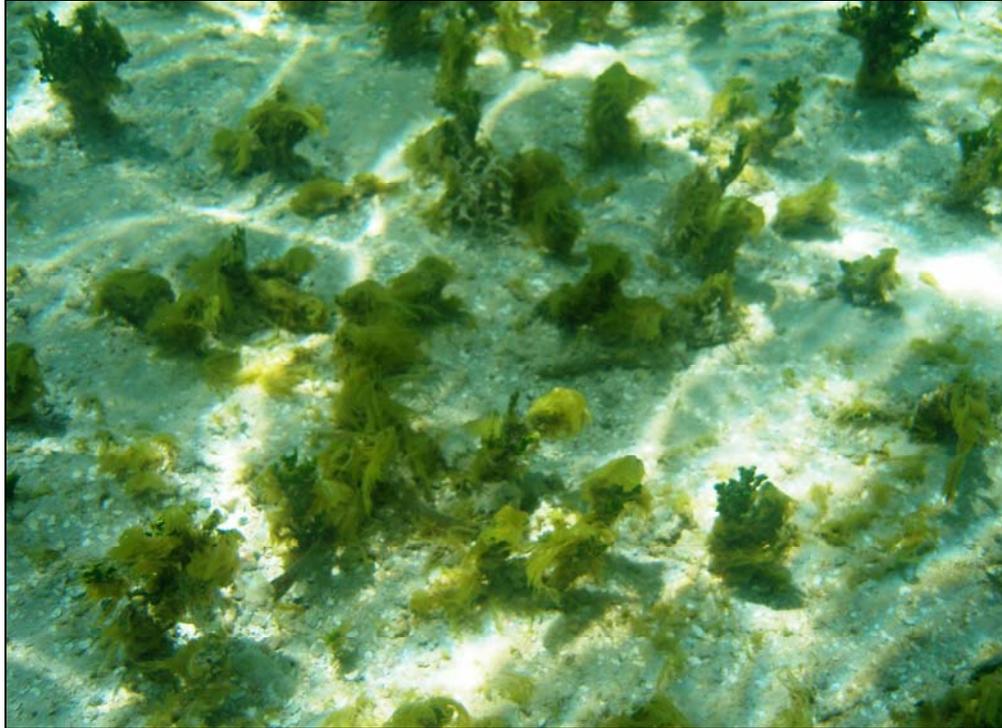
Photo 11: Heavy *Lyngbya* cover remains on calcareous green macroalgae, June 2009

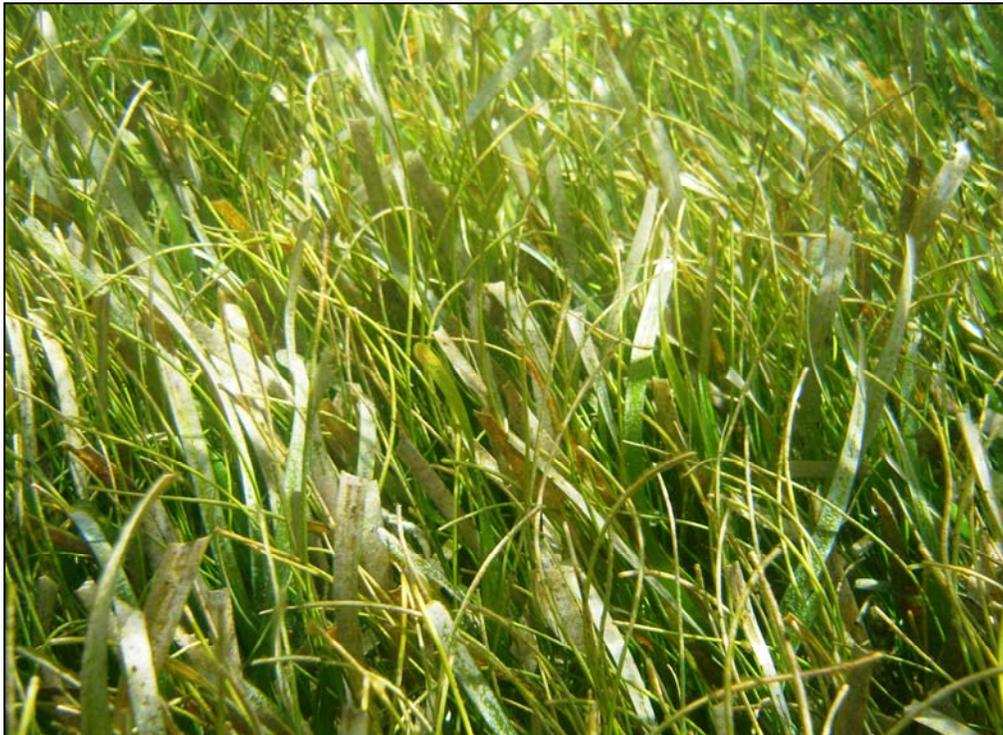
Photo 12: Healthy dense mixed bed of turtle grass and manatee grass along north shoreline of western section of St. Jean Bay, June 2009

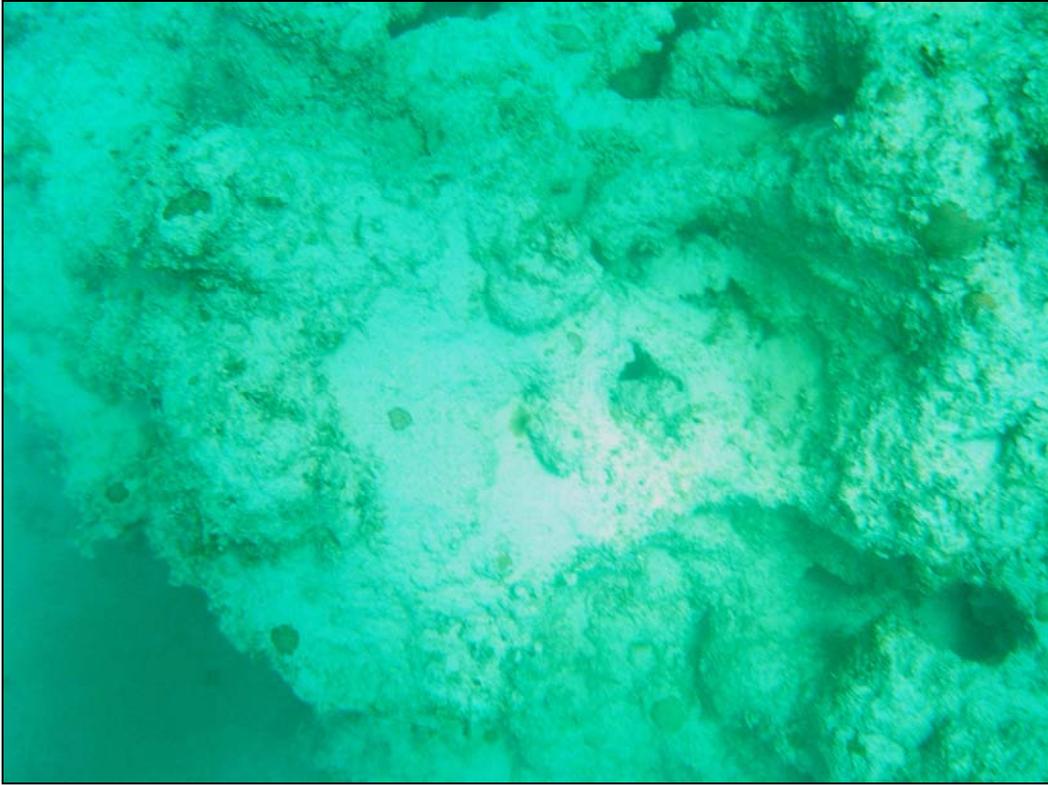
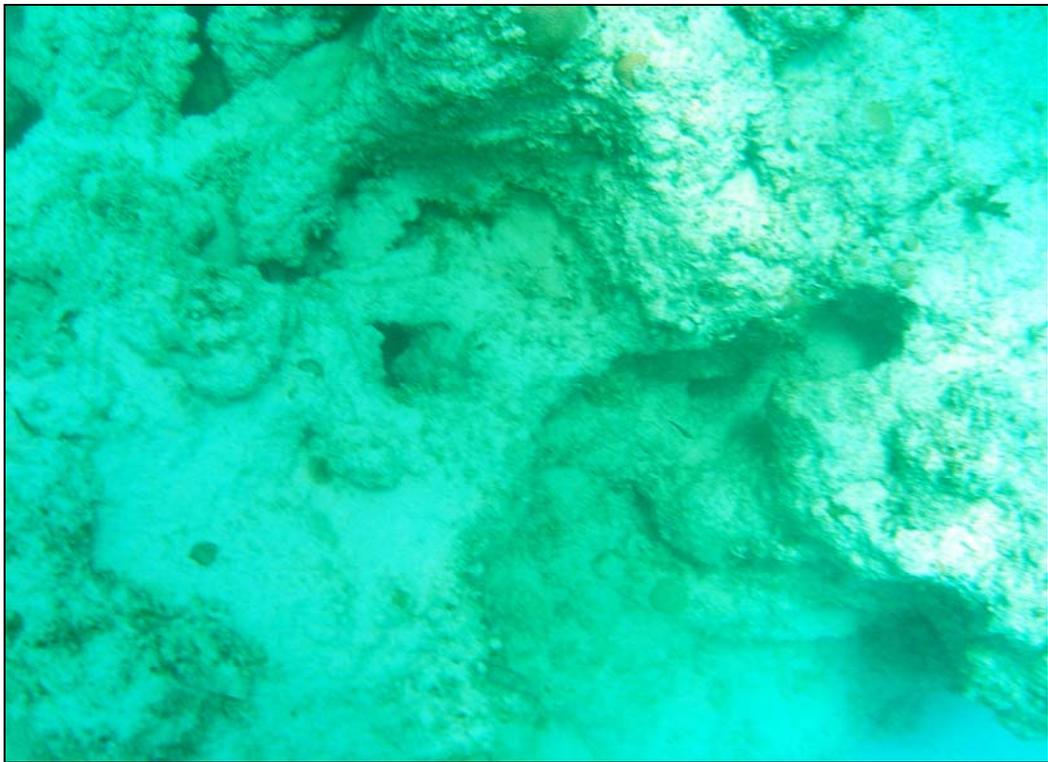
An increase in urchin abundance was observed on the western fringing reef in St. Jean Bay and on Eden Rock in June 2009. Areas of the reef had been cleared of cyanobacteria and fleshy macroalgae by urchin scraping activity, and several colonies of the stony coral *Porites astreoides*, and small colonies of *P. porites* were observed in the cleared areas on the western reef (Photos 15, 16, 21 and 22). *Porites astreoides* is a dominant species recruiting to newly exposed substrate due to the release of brooded planulae which settle rapidly. However, heavy overgrowth of *Lyngbya* and other filamentous cyanobacteria persisted on the western reef and macroalgal-seagrass beds in the west end of St. Jean Bay in June 2009, indicating that top-down control by grazers is not adequate to maintain low levels of fleshy macroalgae in the bay's current nutrient regime (Photos 8, 11, and 17). The landward portion of the central reef and isolated reef patches landward of the central reef remained heavily sedimented with up to 10 cm of fine sand/silt (Photos 13 and 14). Two green sea turtles were observed resting on these patch reefs.

Photos 13 and 14: Heavily silted patch reefs in central portion of St. Jean, June 2009

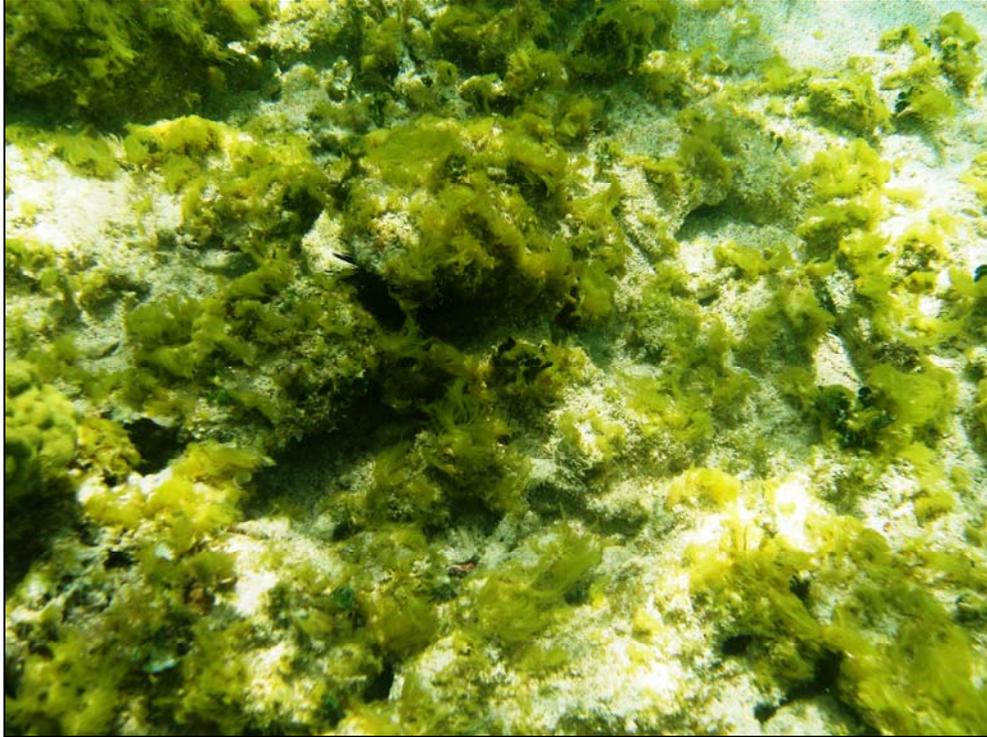
Photo 17: Heavy cover of filamentous cyanobacteria *Lyngbya* persists in seagrass beds and western reef in St. Jean Bay, June 2009

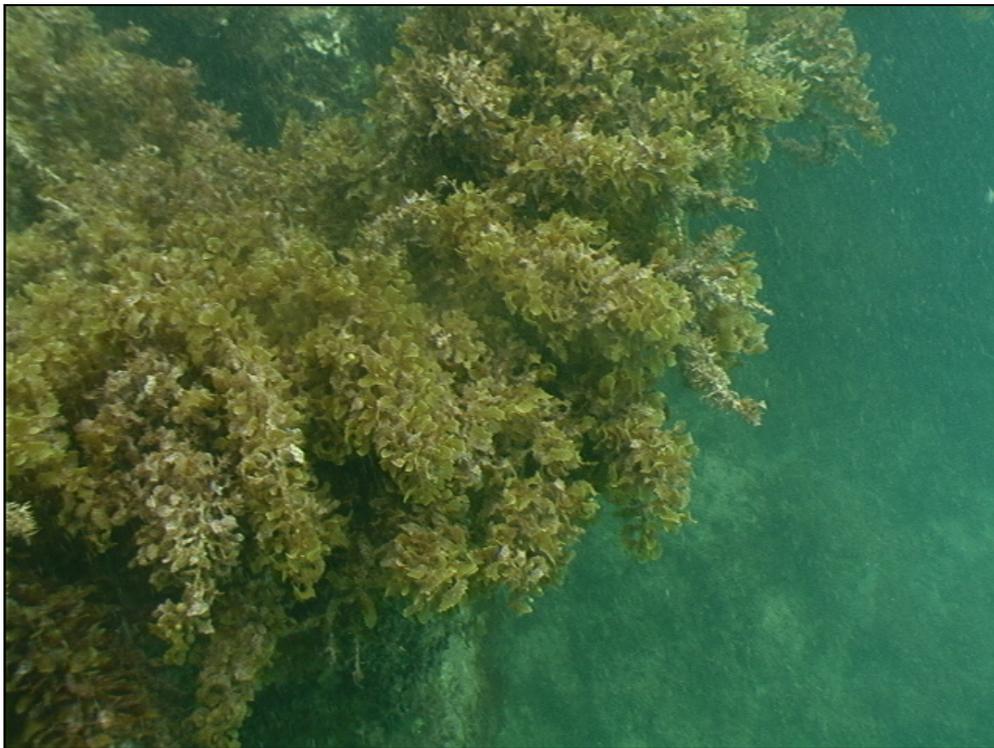
Eden Rock also showed high overgrowth by fleshy macroalgae in April 2009. The dense algal canopy was dominated by *Dictyopteris justii*, *Sargassum polyceratum*, and *Dictyota* spp (Photo 18). These species were also dominant in Discovery Bay, Jamaica, during the transition from coral to macroalgal dominance in the late 1980s (Lapointe et al. 1997). The overgrowth of frondose macroalgae on Eden Rock in April 2009 suggests elevated nutrient levels and reduced herbivory pressure. Few urchins or herbivorous fishes were observed on Eden Rock and St. Jean reef in April 2009.

Photo 18: Eden Rock was almost completely covered in dense fleshy macroalgae in April 2009: *Sargassum*, *Dictyopteris*, *Dicyota* and *Spatoglossum* were dominant genera.

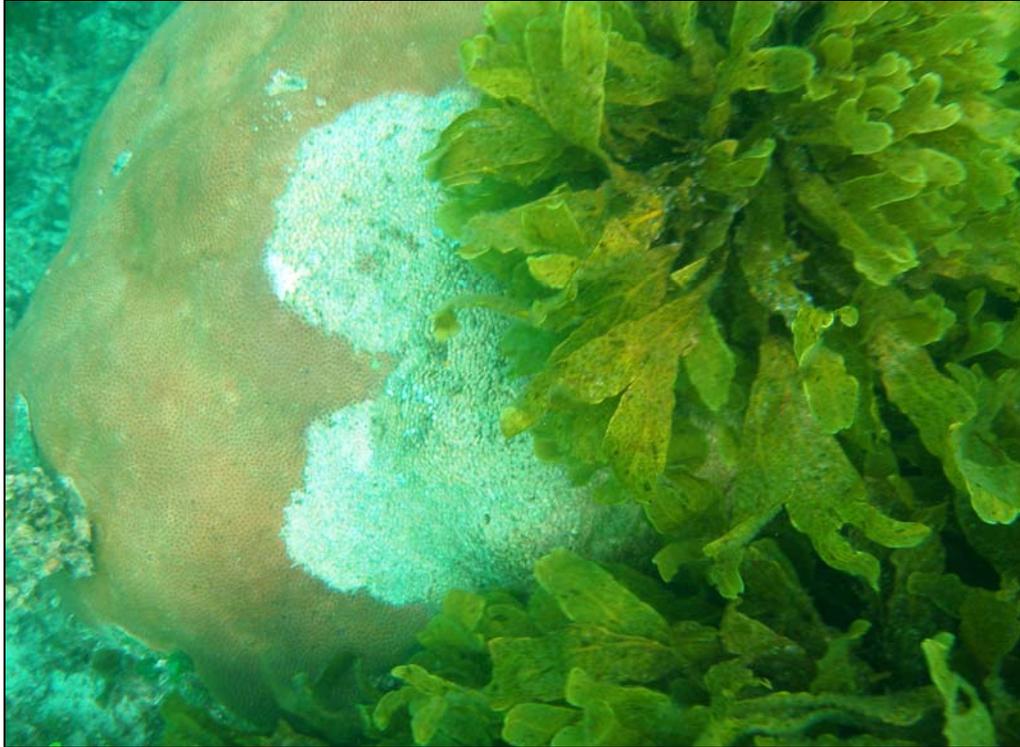
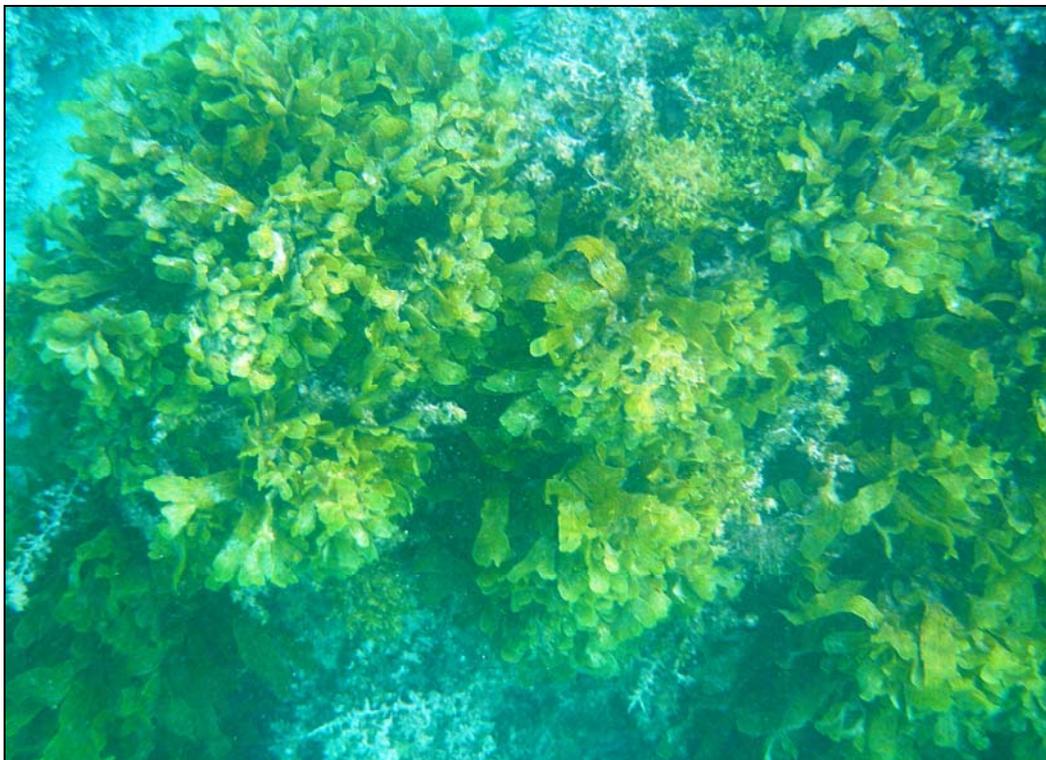
The large increase in the urchin population (*Echinometra lucunter* and *Diadema antillarum*) on Eden Rock in June 2009 appeared to have contributed to the reduction in the fleshy macroalgal canopy (Photos 21 and 22). In June 2009, the inshore portion of the canopy had been largely removed and replaced with a short, wiry turf algal matrix (Photo 23). However, dense algal canopy overgrowth remained in the deeper portions of the rock formation, causing abrasion impacts and tissue loss in the few remaining massive corals at Eden Rock (Photos 19 and 20).

Photos 19 and 20: Large canopy of flesh brown macroalgae remains on the bottom half of the rock formation at Eden Rock in June 2009, causing abrasion impacts and tissue loss in large stony corals.

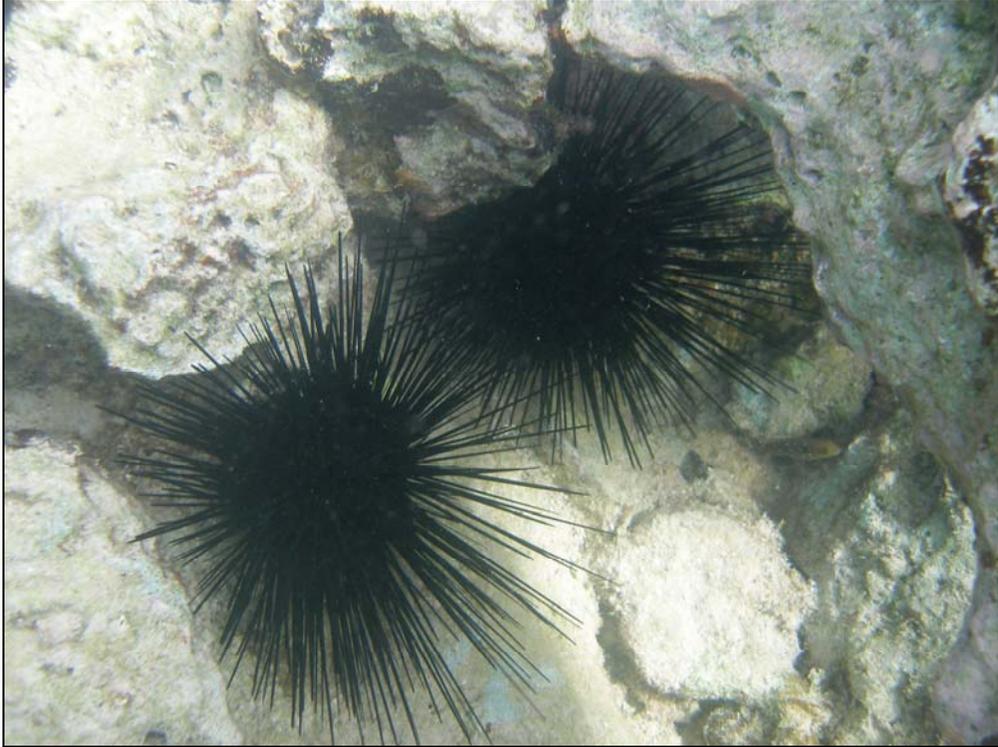
Photo 21: A significant increase in the urchin population (*Diadema* and *Echinometra*) was observed between April and June 2009 at Eden Rock.

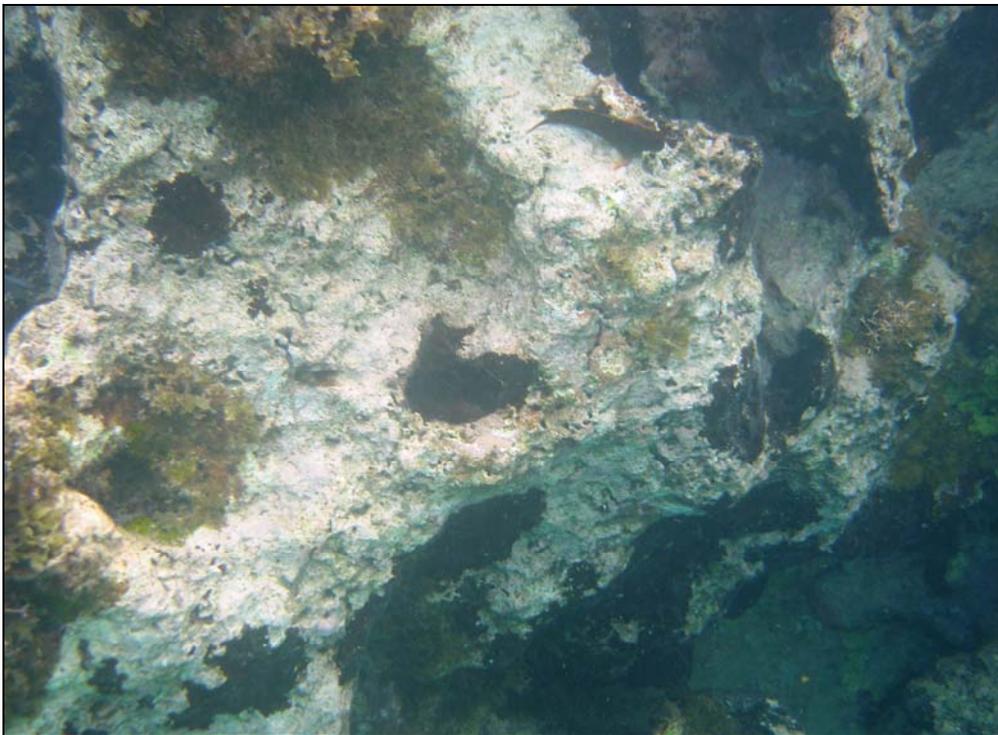
Photo 22: Urchins have removed large areas of fleshy macroalgae on Eden Rock, June 2009

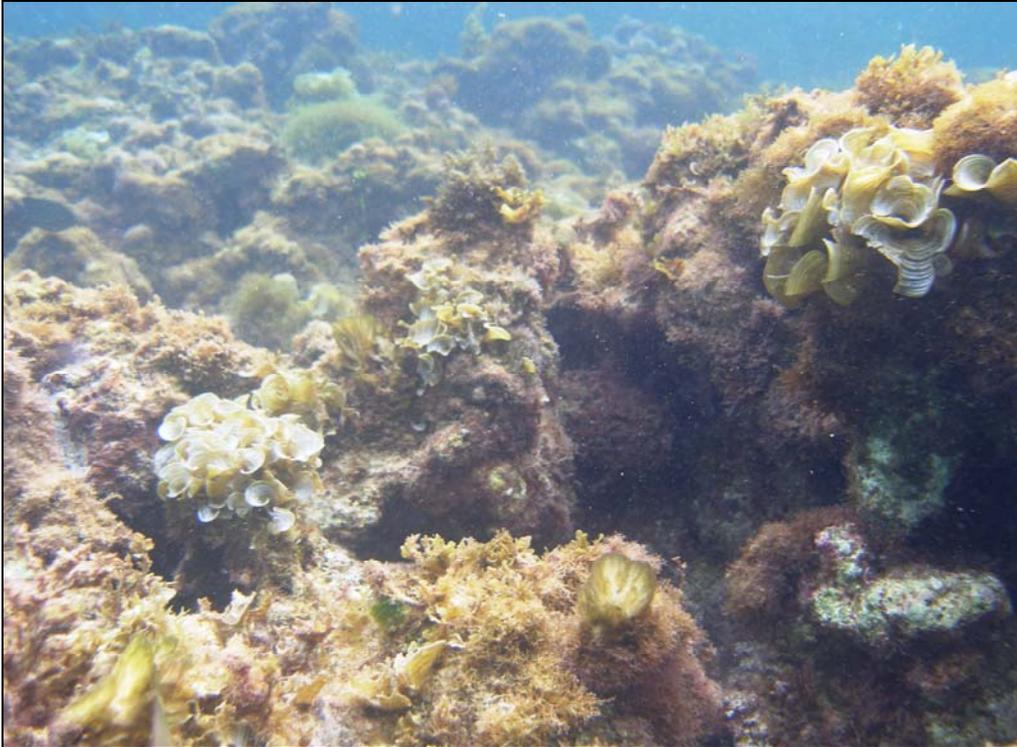
Photo 23: Wiry turf algae and the brown alga *Padina* dominant the upper zone of Eden Rock in June 2009, replacing the overgrowth of fleshy brown macroalgae observed in April 2009

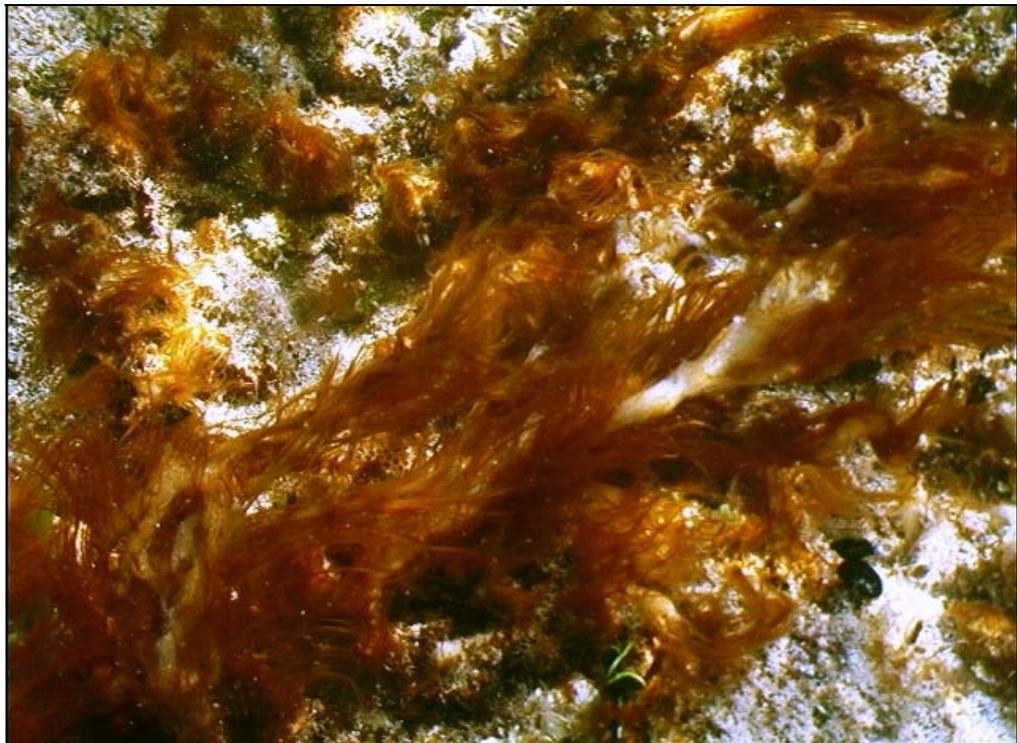
Photo 24: Heavy cover of *Lyngbya* and *Dictyota* was observed on the east reef of Pelican Bay in April 2009

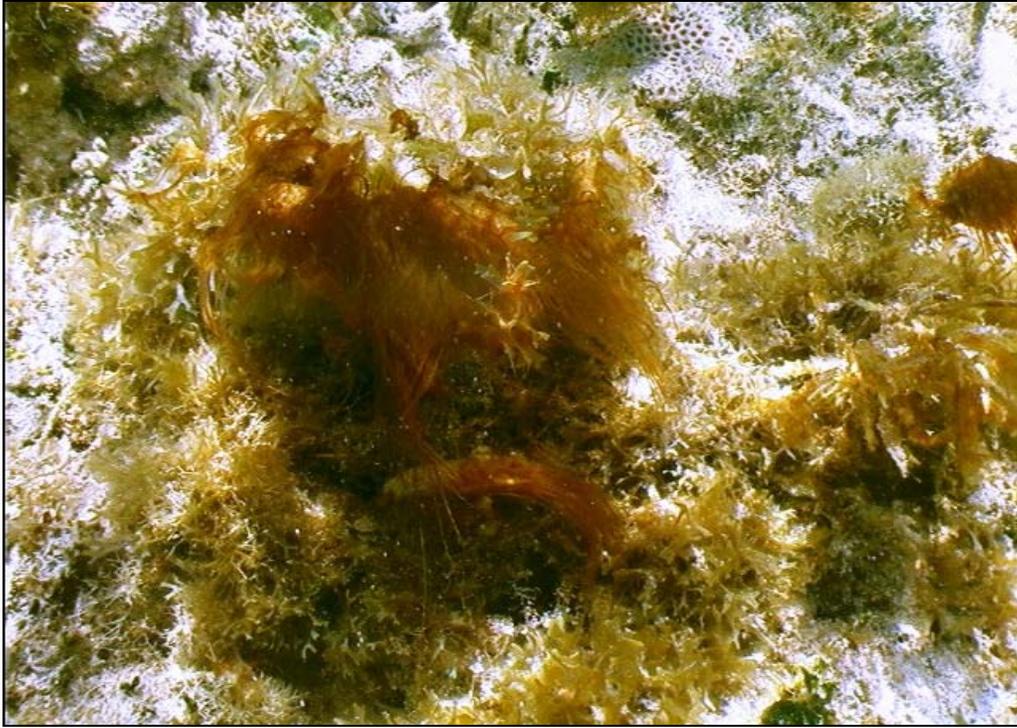
Photo 25: Heavy cover of *Lyngbya* and *Dictyota* on the east reef in Pelican Bay, April 2009

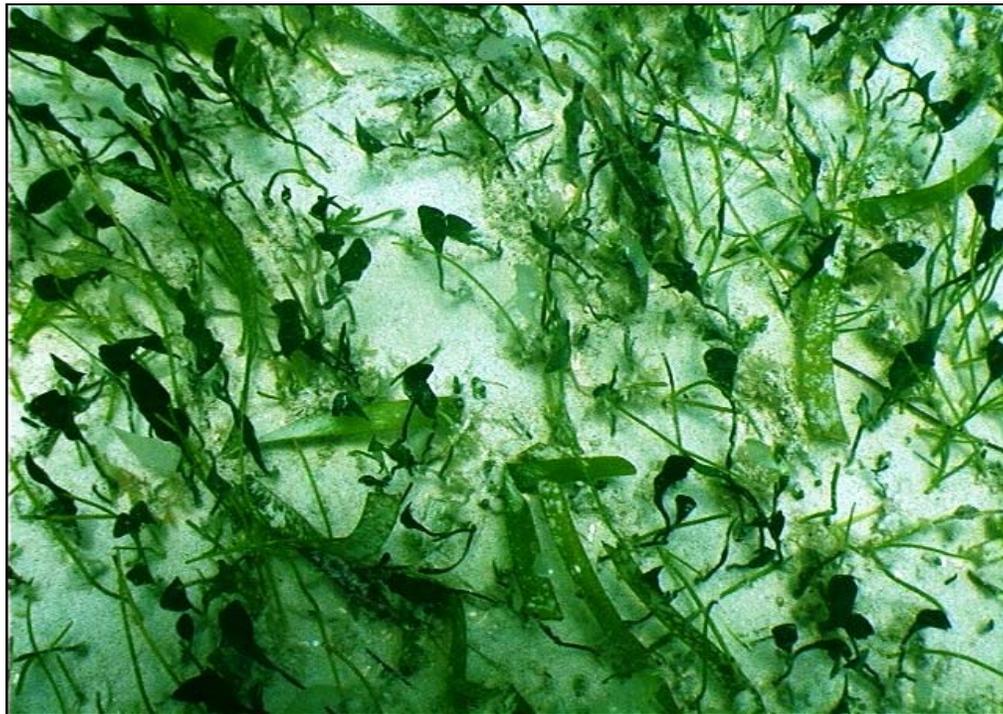
Photo 26: Mixed bed of calcareous green macroalgae dominated by *Caulerpa prolifera* with low to moderate cover of manatee grass (*Syringodium filiforme*) and turtle grass (*Thalassia testudinum*) and low epiphytic cover in Pelican Bay, April 2009

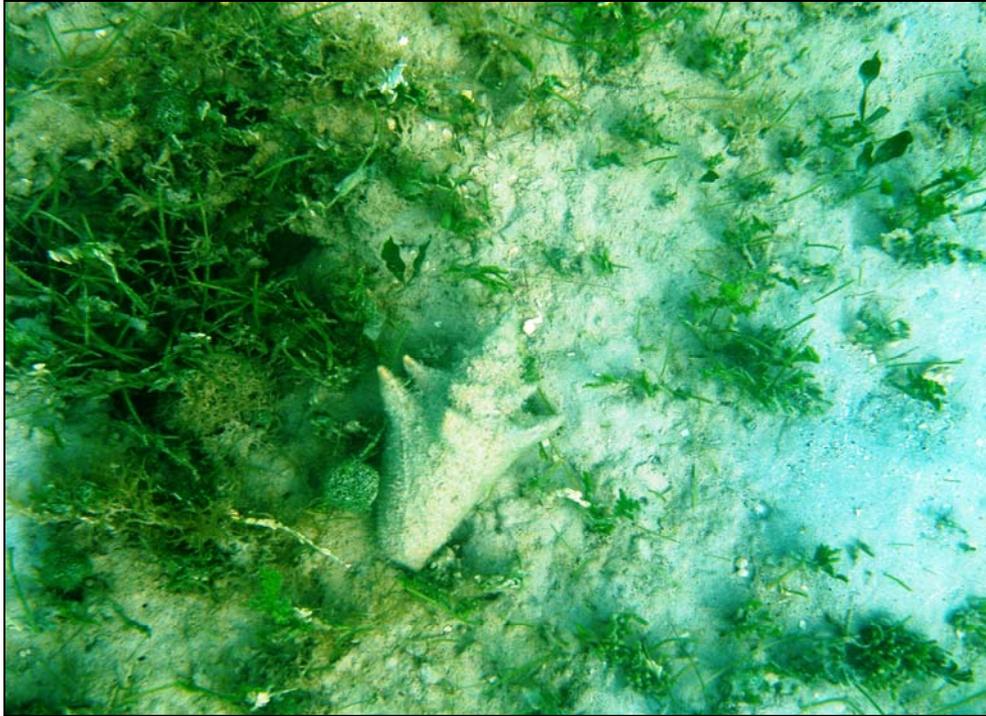
Photo 27: Several conch were observed within the mixed macroalgal-seagrass bed in Pelican Bay, June 2009

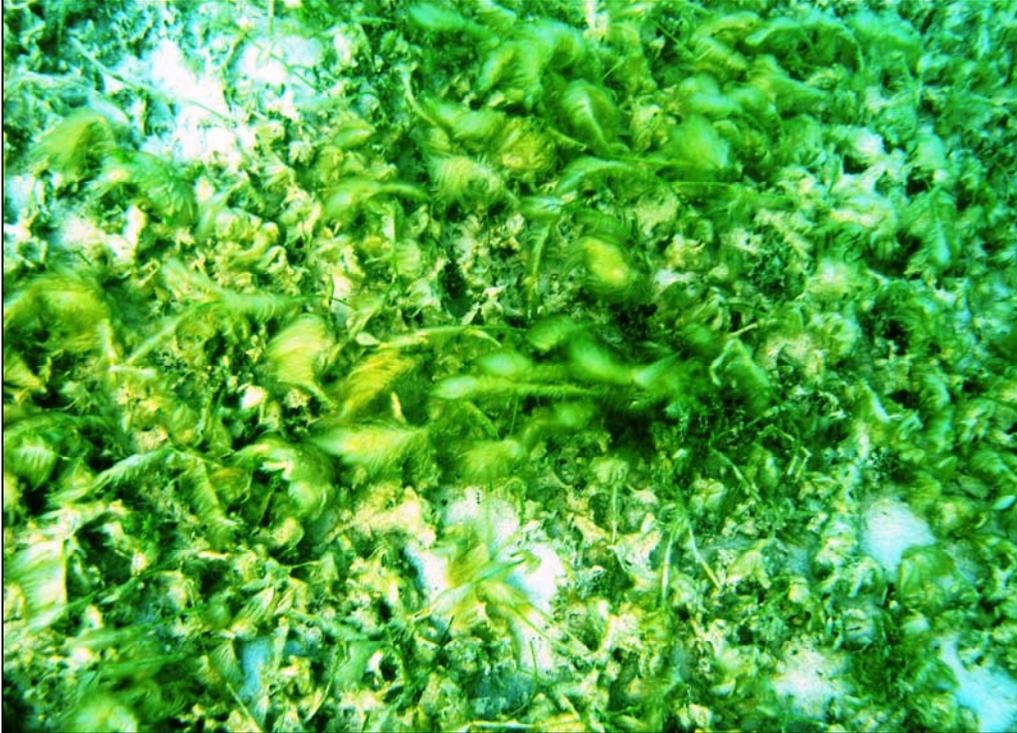
Large changes in cyanobacterial cover were observed between April and June 2009 in Pelican Bay. Significant overgrowth of *Lyngbya* spp was observed on the macroalgal-seagrass beds offshore of Nikki Beach in June 2009 (Photos 28 and 29), and the unvegetated sand bottom was covered with mat cyanobacteria, suggesting potential groundwater nutrient input. This proliferation is of particular concern due to the importance of these seagrass beds as foraging habitat for resident green sea turtles (Photo 30). *Lyngbya* and other cyanobacterial species produce nitrogenous secondary metabolites that serve as chemical defenses against herbivores (Paul et al. 2001).

Photo 29: Epiphytic *Lyngbya* on mixed macroalgae-seagrass bed in Pelican Bay in June 2009.

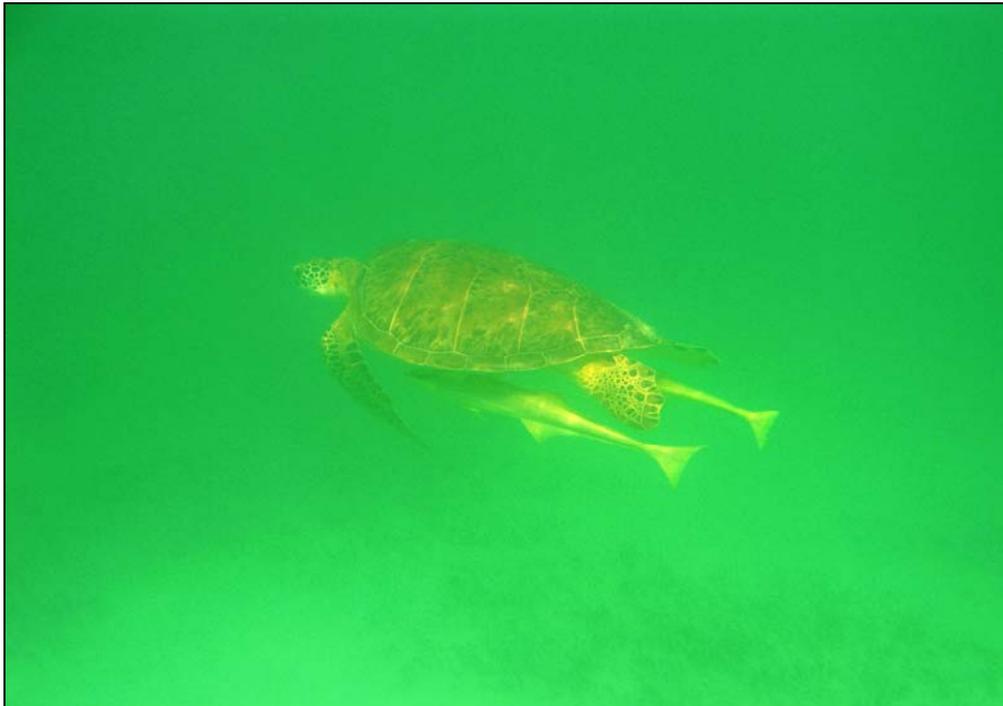
Photo 30: The health of the seagrass beds in Pelican Bay is important for the resident green sea turtles which utilize these beds as foraging habitat, June 2009
