Evaluation of current status of seagrasses and marine ecosystem health in St. Jean Bay, St. Barthelemy FWI

A Sustainable Ecosystems Institute, St Jean Bay Science Group Report

August 2009

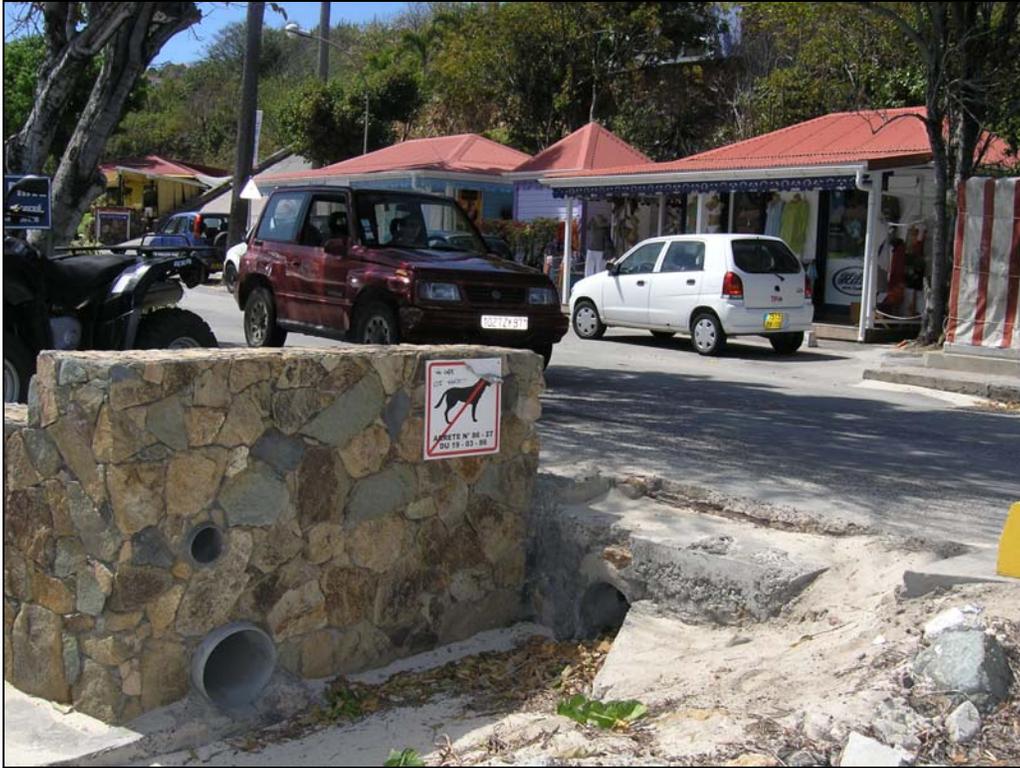
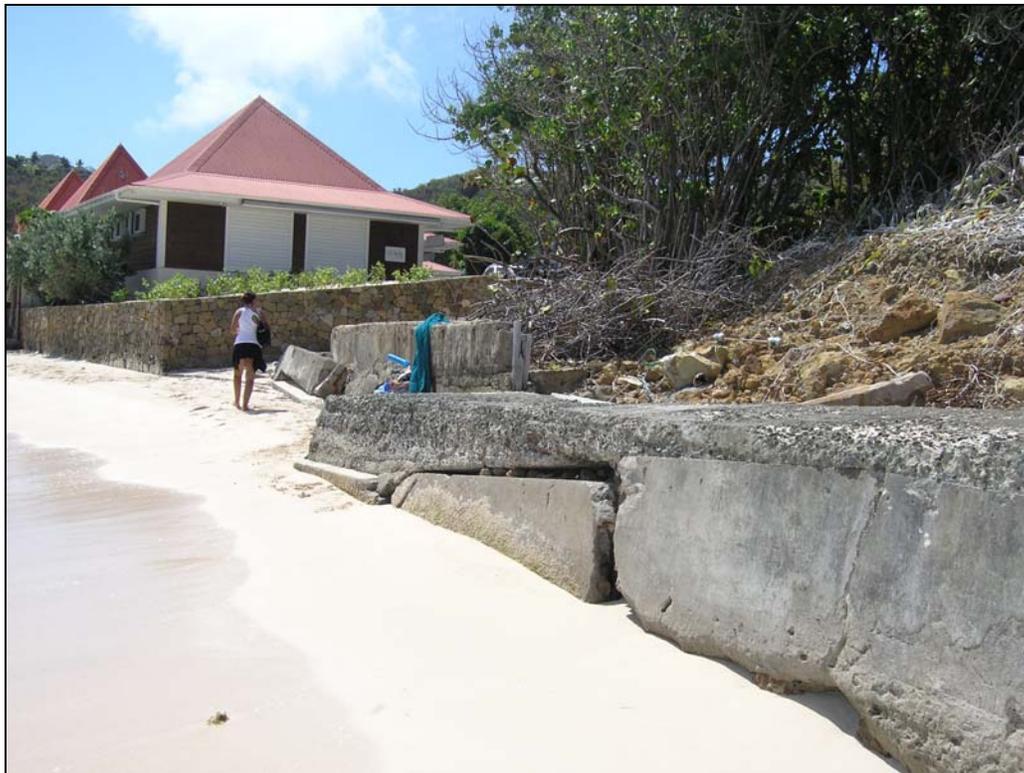
Photos 31 and 32: Stormwater drains directly into Pelican Bay under the road adjacent to Nikki Beach, a direct source of nutrient pollution into Pelican Bay

Seagrasses should not be transplanted in St. Jean Bay at this time. Attempts to restore seagrass should focus on the elimination of the direct sources of nutrient pollution into the bay. Two direct point sources of nutrients were identified during the site visits. Stormwater discharges directly into Pelican Bay through a drainage pipe under the road adjacent to Nikki Beach and directly over the seagrass-calcareous macroalgal beds adjacent to the north shoreline of St. Jean Beach (Photos 31 through 34). These two point sources of pollution must be eliminated by retrofitting the stormwater and discharge outfalls so that they no longer directly discharge into the bay.

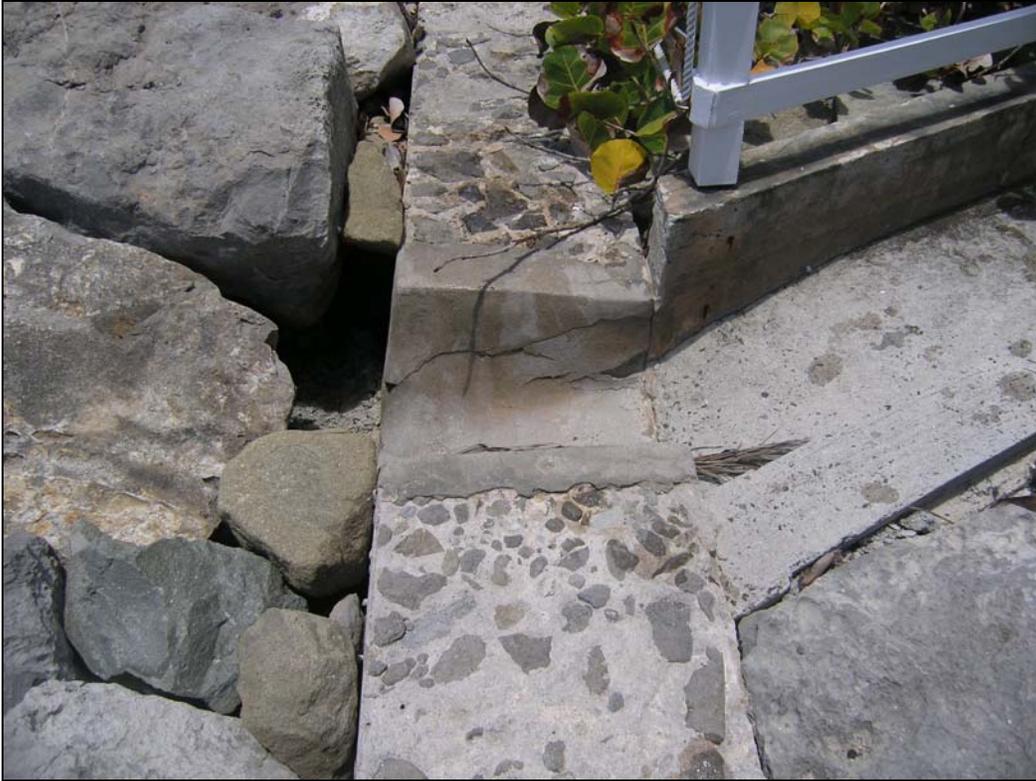
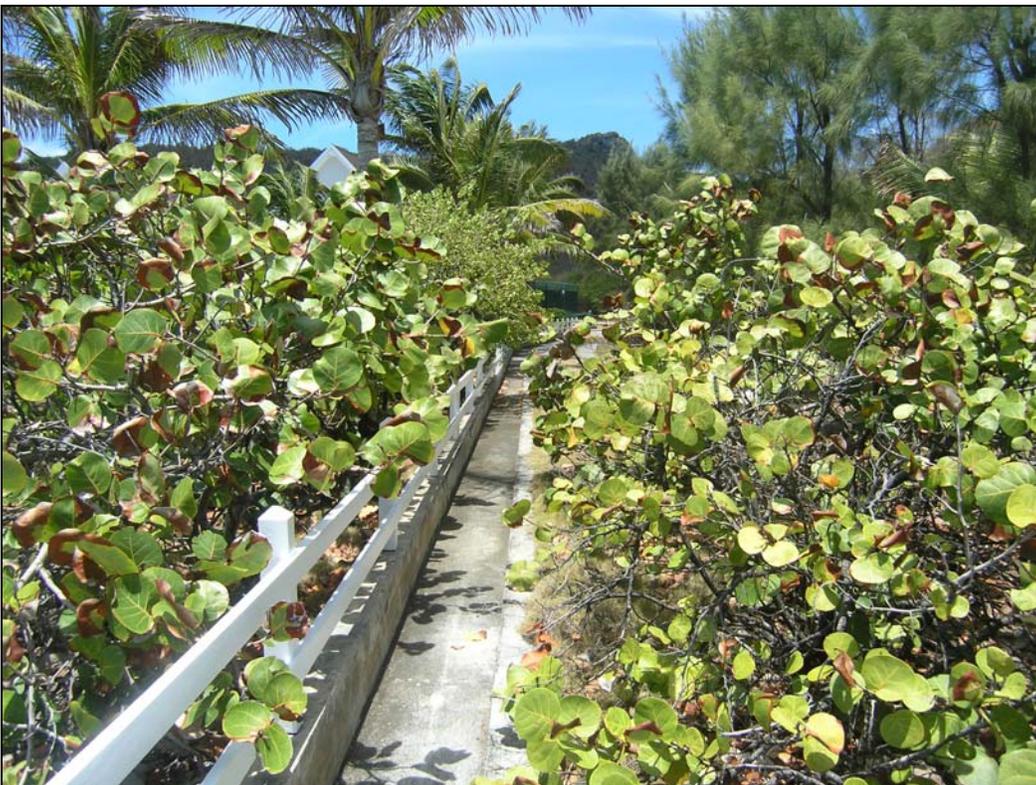
Photos 33 and 34: Stormwater drains directly into west St. Jean Bay in the area under the road adjacent to Nikki Beach, a direct source of nutrient pollution into St. Jean Bay
